**Flood Control Project Maintenance
Levee Inspections**
LMA District Cover Sheet
Spring 2017 Levee Inspection Results

American River Flood Control District

Spring 2017 Levee Inspection Results

Waterway			Bank	Unit Miles
Unit No. 01 Arcade Creek			Left	2.08
	Spring (March - May)	Summer (June - August)	(September - November) Fall	Winter (December - February)
Unit Maintenance Rating (Fall Only)				
Date of Inspection	3/15/2017 - 5/3/2017			
DWR Inspector	Maksim Khashchuk			
Accompanied By	Ross Kawamura ARFCD

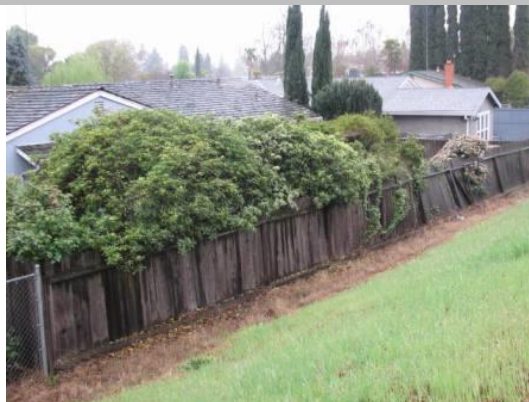
Photo 1 of 1 : SP_2017_NA0001_55_104_20170313_00088.jpg

LM Start	8.41	Rating **	U	Issue No.	104
LM End	8.41	Issue Type +	En	Location *	LS
Category	Earthen Levee			GPS Latitude/Longitude	
				Start	End
Item	Encroachments			38.563108 °	38.563108 °
				-121.390452 °	-121.390452 °
DWR ID	DWR_NA0001_04_s _ 2012_104				
Comment Code					
FE : Fence					
Inspector Comment					
Wood privacy fence within 10-ft of levee toe obstructs access and visibility.

03/16/2012 Wood privacy fence completely obstructs access and visibility.

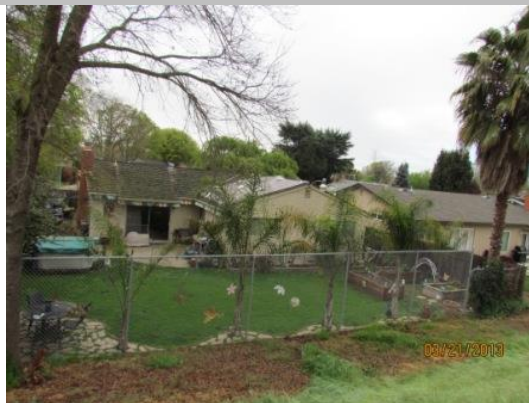
Photo 1 of 1 : SP_2017_NA0001_55_105_20170313_00089.jpg

LM Start	8.44	Rating **	M	Issue No.	105
LM End	8.44	Issue Type +	En	Location *	LS
Category	Earthen Levee			GPS Latitude/Longitude	
				Start	End
Item	Vegetation			38.563238 °	38.563238 °
				-121.390073 °	-121.390073 °
DWR ID	DWR_NA0001_04_s_2012_105				
Comment Code					
V6 : Landscaping					
Inspector Comment					
Palms planted within 10-ft of the levee toe.

View of the palm trees at the levee toe.

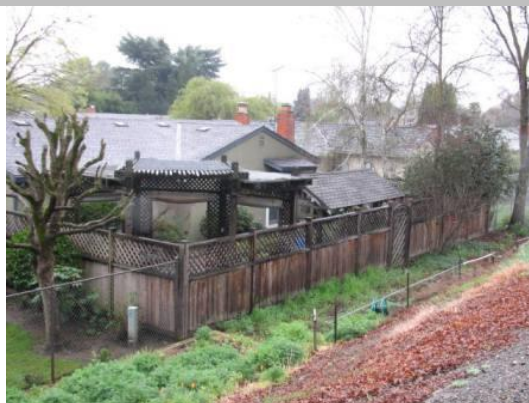
Photo 1 of 1 : SP_2017_NA0001_55_106_20170313_00090.jpg

LM Start	8.45	Rating **	U	Issue No.	106
LM End	8.45	Issue Type +	En	Location *	LS
Category	Earthen Levee			GPS Latitude/Longitude	
				Start	End
Item	Encroachments			38.563308 °	38.563308 °
				-121.389885 °	-121.389885 °
DWR ID	DWR_NA0001_04_s_2012_106				
Comment Code					
FE : Fence					
Inspector Comment					
Wood privacy fence within 10-ft of levee toe obstructs access and visibility. Block wall built into the levee.

03/16/2012 Wood privacy fence completely obstructs access and visibility.

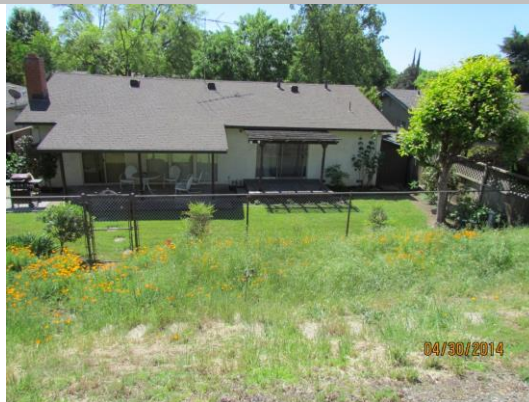
Photo 1 of 1 : SP_2017_NA0001_55_246_20170313_00189.jpg

LM Start	8.46	Rating **	M	Issue No.	246
LM End	8.46	Issue Type +	En	Location *	LS
Category	Earthen Levee			GPS Latitude/Longitude	
				Start	End
Item	Encroachments			38.563434 °	38.563434 °
				-121.389675 °	-121.389675 °
DWR ID	DWR_NA0001_04_s_2014_246				
Comment Code					
RW : Retaining Wall					
Inspector Comment					
Retaining wall and irrigation at landside levee toe.

View of the irrigation and retaining wall at the landside levee toe.

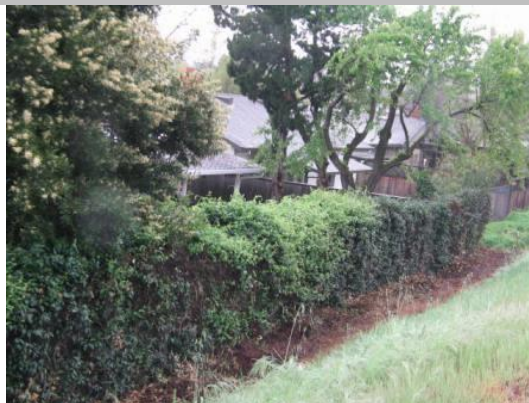
Photo 1 of 1 : SP_2017_NA0001_55_107_20170313_00091.jpg

LM Start	8.47	Rating **	U	Issue No.	107
LM End	8.47	Issue Type +	En	Location *	LS
Category	Earthen Levee			GPS Latitude/Longitude	
				Start	End
Item	Vegetation			38.563511 °	38.563511 °
				-121.389509 °	-121.389509 °
DWR ID	DWR_NA0001_04_s_2012_107				
Comment Code					
V6 : Landscaping					
Inspector Comment

03/16/2012 Landscaping obstructs visibility and access.

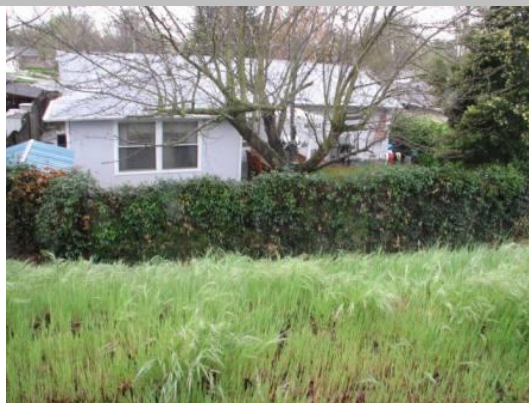
Photo 1 of 1 : SP_2017_NA0001_55_108_20170313_00092.jpg

LM Start	8.48	Rating **	U	Issue No.	108
LM End	8.48	Issue Type +	En	Location *	LS
Category	Earthen Levee			GPS Latitude/Longitude	
				Start	End
Item	Vegetation			38.563587 °	38.563587 °
				-121.389313 °	-121.389313 °
DWR ID	DWR_NA0001_04_s_2012_108				
Comment Code					
V6 : Landscaping					
Inspector Comment

03/16/2012 Landscaping obstructs visibility and access.

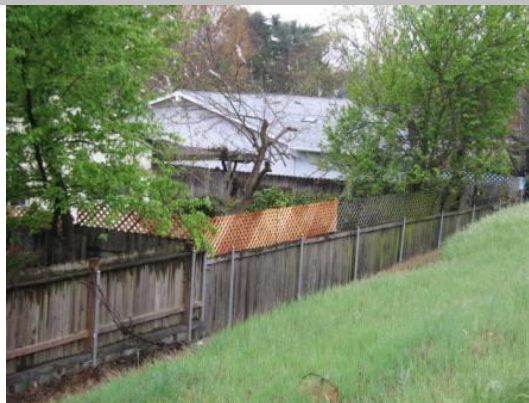
Photo 1 of 1 : SP_2017_NA0001_55_109_20170313_00093.jpg

LM Start	8.49	Rating **	U	Issue No.	109
LM End	8.49	Issue Type +	En	Location *	LS
Category	Earthen Levee			GPS Latitude/Longitude	
				Start	End
Item	Encroachments			38.563580 °	38.563580 °
				-121.389140 °	-121.389140 °
DWR ID	DWR_NA0001_04_s_2012_109				
Comment Code					
FE : Fence					
Inspector Comment					
Wood privacy fence within 10-ft of levee toe obstructs access and visibility.

03/16/2012 Wood privacy fence completely obstructs access and visibility.

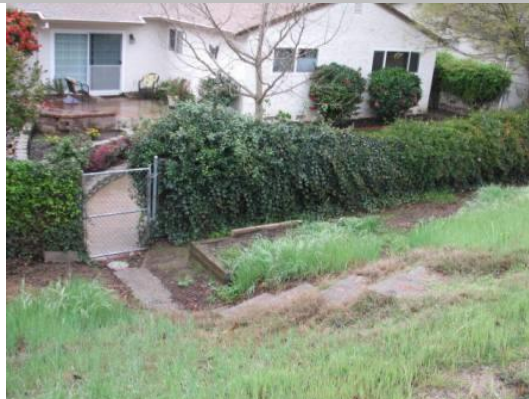
Photo 1 of 1 : SP_2017_NA0001_55_113_20170313_00097.jpg

LM Start	8.55	Rating **	U	Issue No.	113
LM End	8.55	Issue Type +	En	Location *	LS
Category	Earthen Levee			GPS Latitude/Longitude	
				Start	End
Item	Vegetation			38.563963 °	38.563963 °
				-121.388135 °	-121.388135 °
DWR ID	DWR_NA0001_04_s_2012_113				
Comment Code					
V6 : Landscaping					
Inspector Comment

03/16/2012 Landscaping on chainlink fence blocks visibility and access.

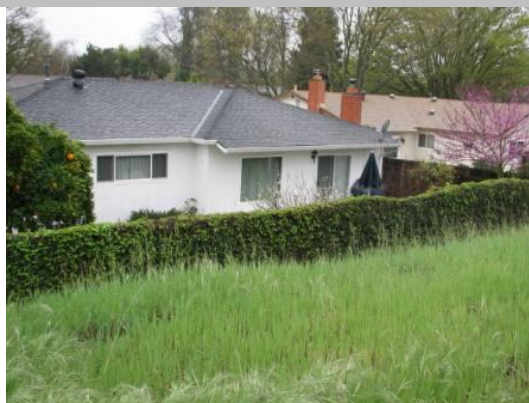
Photo 1 of 1 : SP_2017_NA0001_55_114_20170313_00098.jpg

LM Start	8.57	Rating **	U	Issue No.	114
LM End	8.57	Issue Type +	En	Location *	LS
Category	Earthen Levee			GPS Latitude/Longitude	
				Start	End
Item	Vegetation			38.564020 °	38.564020 °
				-121.387887 °	-121.387887 °
DWR ID	DWR_NA0001_04_s_2012_114				
Comment Code					
V6 : Landscaping					
Inspector Comment					
Ivy and orange tree obstruct visibility.

03/16/2012 Ivy on chainlink fence completely obstructs visibility and access.

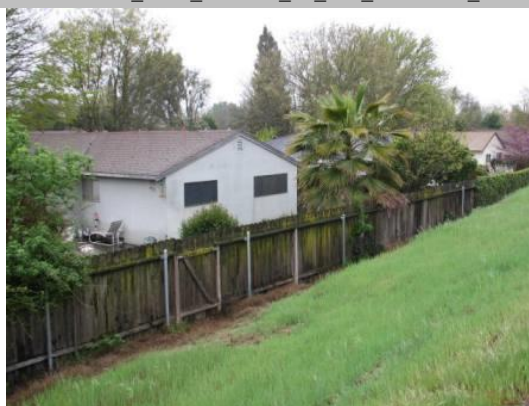
Photo 1 of 1 : SP_2017_NA0001_55_115_20170313_00099.jpg

LM Start	8.58	Rating **	U	Issue No.	115
LM End	8.58	Issue Type +	En	Location *	LS
Category	Earthen Levee			GPS Latitude/Longitude	
				Start	End
Item	Encroachments			38.564047 °	38.564047 °
				-121.387743 °	-121.387743 °
DWR ID	DWR_NA0001_04_s_2012_115				
Comment Code					
FE : Fence					
Inspector Comment					
Wood privacy fence within 10-ft of levee toe obstructs access and visibility.

03/16/2012 Wood privacy fence completely obstructs access and visibility.

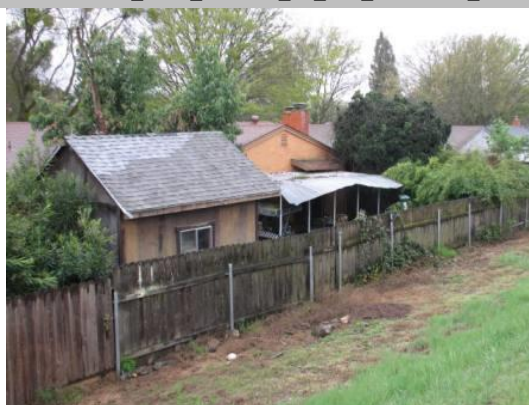
Photo 1 of 1 : SP_2017_NA0001_55_117_20170313_00101.jpg

LM Start	8.59	Rating **	U	Issue No.	117
LM End	8.59	Issue Type +	En	Location *	LS
Category	Earthen Levee			GPS Latitude/Longitude	
				Start	End
Item	Encroachments			38.564094 °	38.564094 °
				-121.387498 °	-121.387498 °
DWR ID	DWR_NA0001_04_s_2012_117				
Comment Code					
FE : Fence					
Inspector Comment					
Wood privacy fence and wood out building within 10-ft of levee toe obstructs access and visibility.

03/16/2012 Wood privacy fence completely obstructs access and visibility.

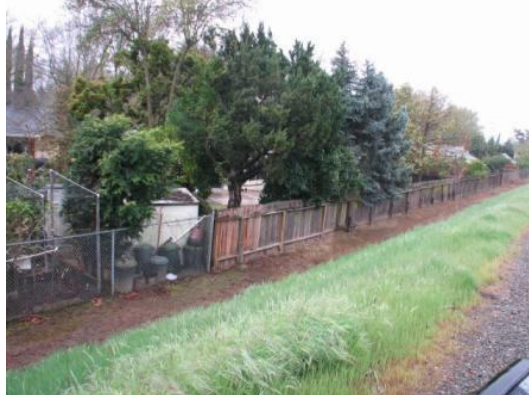
Photo 1 of 1 : SP_2017_NA0001_55_119_20170313_00103.jpg

LM Start	8.63	Rating **	U	Issue No.	119
LM End	8.63	Issue Type +	En	Location *	LS
Category	Earthen Levee			GPS Latitude/Longitude	
				Start	End
Item	Encroachments			38.564217 °	38.564217 °
				-121.386846 °	-121.386846 °
DWR ID	DWR_NA0001_04_s_2012_119				
Comment Code					
FE : Fence					
Inspector Comment					
Wood privacy fence within 10-ft of levee toe obstructs access and visibility.

03/16/2012 Wood privacy fence completely obstructs access and visibility.

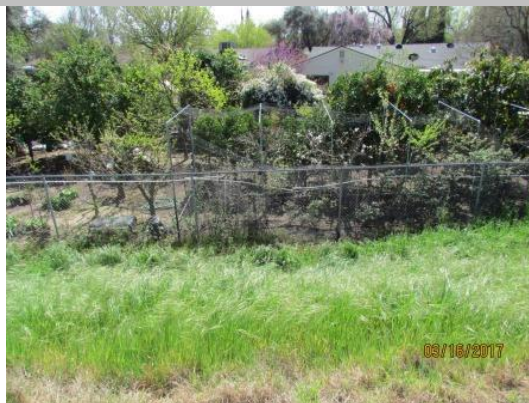
Photo 1 of 1 : SP_2017_NA0001_55_254_20170406_00256.jpg

LM Start	8.64	Rating **	M	Issue No.	254
LM End	8.64	Issue Type +	En	Location *	LS
Category	Earthen Levee			GPS Latitude/Longitude	
				Start	End
Item	Encroachments			38.564257 °	38.564257 °
				-121.386543 °	-121.386543 °
DWR ID	DWR_NA0001_04_s_2017_254				
Comment Code					
FE : Fence					
Inspector Comment					
Chain link fence blocking access.

View of the fence at the levee toe.

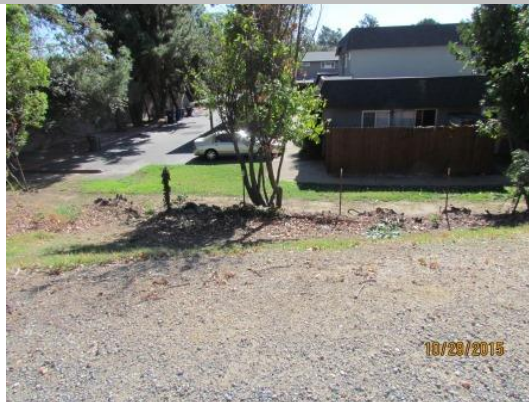
Photo 1 of 1 : SP_2017_NA0001_55_230_20170313_00179.jpg

LM Start	8.83	Rating **	N	Issue No.	230
LM End	8.83	Issue Type +	Ma	Location *	LS
Category	Earthen Levee			GPS Latitude/Longitude	
				Start	End
Item	Trim / Thin Trees			38.564929 °	38.564929 °
				-121.383248 °	-121.383248 °
DWR ID	DWR_NA0001_04_f_2015_230				
Comment Code					
T5 : Tree stumps.					
Inspector Comment					
5 shrub stumps with multiple branches.

View of the multiple tree stumps at the landside levee toe.

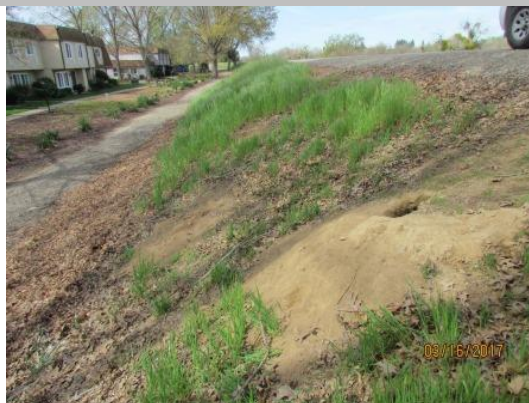
Photo 1 of 2 : SP_2017_NA0001_55_249_20170406_00255.jpg

LM Start	9.30	Rating **	U	Issue No.	249	
LM End	9.30	Issue Type +	Ma	Location *	LS	
Category	Earthen Levee			GPS Latitude/Longitude		
				Start		End
Item	Animal Control			38.566685 °		38.566685 °
				-121.374818 °		-121.374818 °
DWR ID	DWR_NA0001_04_s _ 2017_249					
Comment Code						
A1 : Exterminate rodents and backfill and compact or grout burrows.						
Inspector Comment						
Multiple active rodent holes.

View of the rodent burrows on the levee slope, looking upstream.

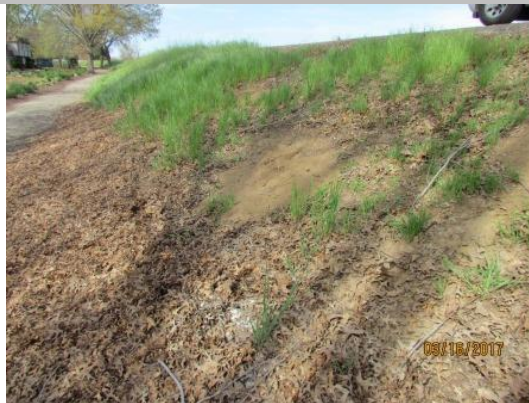
Photo 2 of 2 : SP_2017_NA0001_55_249_20170406_00254.jpg

LM Start	9.30	Rating **	U	Issue No.	249 (cont)
LM End	9.30	Issue Type +	Ma	Location *	LS

Another view of the rodent burrows on the levee slope.

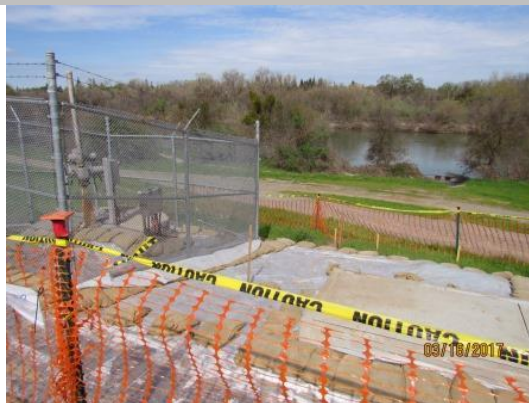
Photo 1 of 1 : SP_2017_NA0001_55_236_20170517_00284.jpg

LM Start	9.41	Rating **	A/W	Issue No.	236
LM End	9.41	Issue Type +	Ma	Location *	WS
Category	Earthen Levee			GPS Latitude/Longitude	
				Start	End
Item	Erosion / Bank Caving			38.566711 °	38.566711 °
				-121.372912 °	-121.372912 °
DWR ID	DWR_NA0001_04_s_2017_236				
Comment Code					
E1 : Note and monitor erosion site.					
Inspector Comment					
Sinkhole in top portion of waterside levee slope identified Feb 2017. County should conduct permanent repair of site.

View of the temporarily repaired slope.

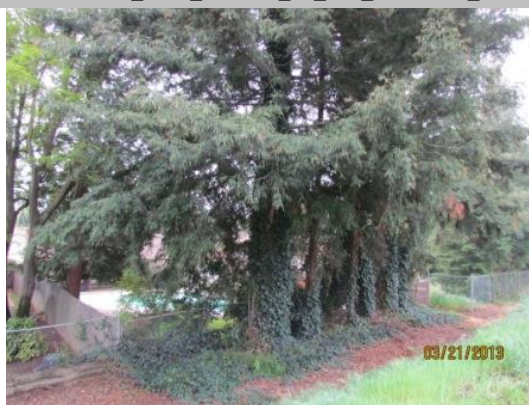
Photo 1 of 1 : SP_2017_NA0001_55_237_20170313_00183.jpg

LM Start	9.48	Rating **	M	Issue No.	237
LM End	9.48	Issue Type +	En	Location *	LS
Category	Earthen Levee			GPS Latitude/Longitude	
				Start	End
Item	Vegetation			38.566961 °	38.566961 °
				-121.371544 °	-121.371544 °
DWR ID	DWR_NA0001_04_s_2012_237				
Comment Code					
V6 : Landscaping					
Inspector Comment					
Redwoods and ivy along fence within 10-ft of levee toe.

View of landscaping at levee toe.

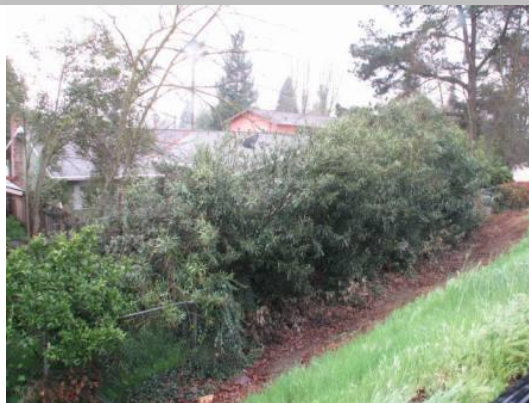
Photo 1 of 1 : SP_2017_NA0001_55_121_20170313_00104.jpg

LM Start	9.52	Rating **	U	Issue No.	121
LM End	9.52	Issue Type +	En	Location *	LS
Category	Earthen Levee			GPS Latitude/Longitude	
				Start	End
Item	Vegetation			38.567073 °	38.567073 °
				-121.370933 °	-121.370933 °
DWR ID	DWR_NA0001_04_s_2012_121				
Comment Code					
V6 : Landscaping					
Inspector Comment					
Oleander bushes and shrubs within 10-ft of landside toe.

03/16/2012 Landscaping obstructs visibility and access.

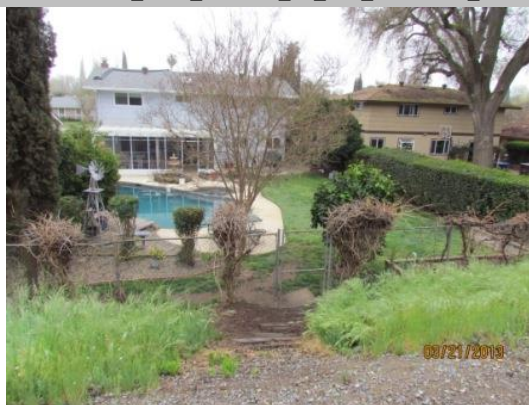
Photo 1 of 1 : SP_2017_NA0001_55_124_20170313_00107.jpg

LM Start	9.57	Rating **	M	Issue No.	124
LM End	9.57	Issue Type +	En	Location *	LS
Category	Earthen Levee			GPS Latitude/Longitude	
				Start	End
Item	Vegetation			38.567274 °	38.567274 °
				-121.369926 °	-121.369926 °
DWR ID	DWR_NA0001_04_s_2012_124				
Comment Code					
V6 : Landscaping					
Inspector Comment					
Ivy and vines on chain link fence within 10-ft of levee toe.

View of landscaping at levee toe.

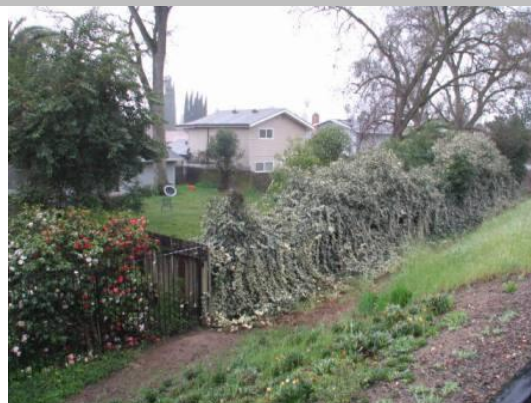
Photo 1 of 1 : SP_2017_NA0001_55_125_20170313_00108.jpg

LM Start	9.60	Rating **	U	Issue No.	125
LM End	9.60	Issue Type +	En	Location *	LS
Category	Earthen Levee			GPS Latitude/Longitude	
				Start	End
Item	Vegetation			38.567360 °	38.567360 °
				-121.369555 °	-121.369555 °
DWR ID	DWR_NA0001_04_s _ 2012_125				
Comment Code					
V6 : Landscaping					
Inspector Comment					
Dense golden ivy on C/L fence obstructs access and visibility.

03/16/2012 Landscaping obstructs visibility and access.

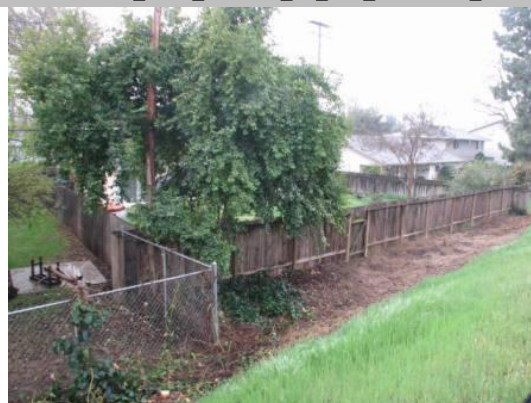
Photo 1 of 1 : SP_2017_NA0001_55_128_20170313_00109.jpg

LM Start	9.65	Rating **	U	Issue No.	128
LM End	9.65	Issue Type +	En	Location *	LS
Category	Earthen Levee			GPS Latitude/Longitude	
				Start	End
Item	Encroachments			38.567493 °	38.567493 °
				-121.368633 °	-121.368633 °
DWR ID	DWR_NA0001_04_s _ 2012_128				
Comment Code					
FE : Fence					
Inspector Comment					
Wooden privacy fence within 10-ft of levee toe.

03/16/2012 Wood privacy fence completely obstructs access and visibility.

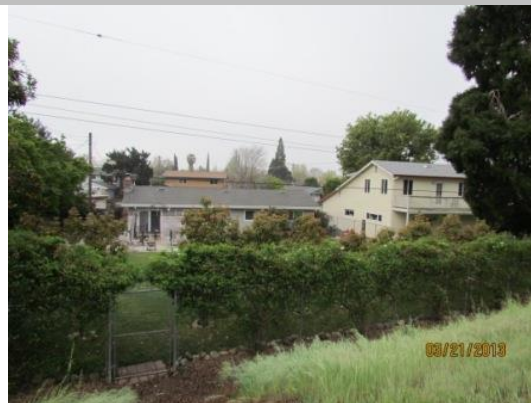
Photo 1 of 1 : SP_2017_NA0001_55_129_20170313_00110.jpg

LM Start	9.67	Rating **	M	Issue No.	129
LM End	9.67	Issue Type +	En	Location *	LS
Category	Earthen Levee			GPS Latitude/Longitude	
				Start	End
Item	Vegetation			38.567594 °	38.567594 °
				-121.368195 °	-121.368195 °
DWR ID	DWR_NA0001_04_s _ 2012_129				
Comment Code					
V6 : Landscaping					
Inspector Comment					
Trees and vines along C/L fence within 10-ft of levee toe.

View of landscaping at levee toe.

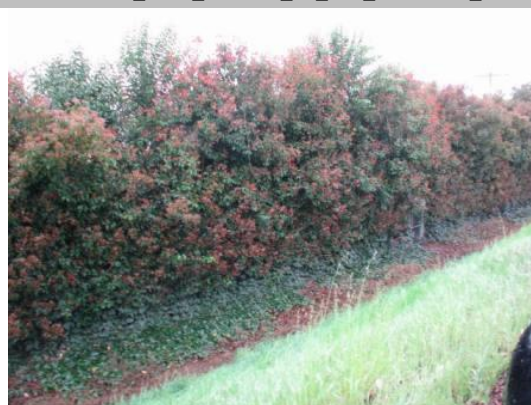
Photo 1 of 1 : SP_2017_NA0001_55_130_20170313_00111.jpg

LM Start	9.69	Rating **	U	Issue No.	130
LM End	9.69	Issue Type +	En	Location *	LS
Category	Earthen Levee			GPS Latitude/Longitude	
				Start	End
Item	Vegetation			38.567626 °	38.567626 °
				-121.367921 °	-121.367921 °
DWR ID	DWR_NA0001_04_s _ 2012_130				
Comment Code					
V6 : Landscaping					
Inspector Comment					
Tall hedge obstructs access and visibility.

03/16/2012 Tall hedge obstructs visibility and access.

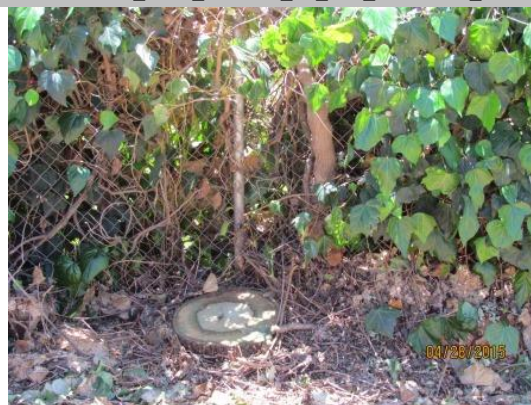
Photo 1 of 1 : SP_2017_NA0001_55_234_20170313_00180.jpg

LM Start	9.72	Rating **	N	Issue No.	234	
LM End	9.72	Issue Type +	Ma	Location *	LS	
Category	Earthen Levee			GPS Latitude/Longitude		
				Start		End
Item	Trim / Thin Trees			38.567761 °		38.567761 °
				-121.367363 °		-121.367363 °
DWR ID	DWR_NA0001_04_s _ 2015_234					
Comment Code						
T5 : Tree stumps.						
Inspector Comment

View of the tree stump at the landside levee toe.

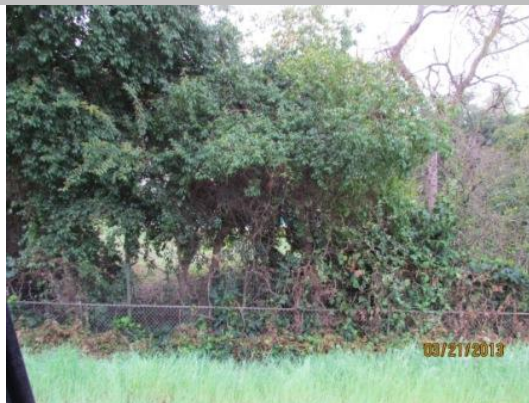
Photo 1 of 1 : SP_2017_NA0001_55_132_20170313_00113.jpg

LM Start	9.72	Rating **	M	Issue No.	132
LM End	9.72	Issue Type +	En	Location *	LS
Category	Earthen Levee			GPS Latitude/Longitude	
				Start	End
Item	Vegetation			38.567772 °	38.567772 °
				-121.367227 °	-121.367227 °
DWR ID	DWR_NA0001_04_s _ 2012_132				
Comment Code					
V6 : Landscaping					
Inspector Comment					
Trees and ivy on levee slope obstruct access and visibility.

View of obstructive landscaping.

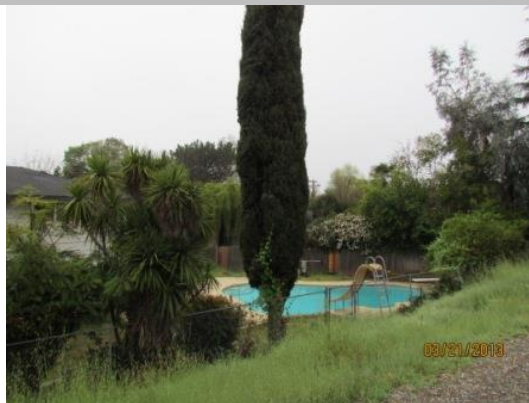
Photo 1 of 1 : SP_2017_NA0001_55_133_20170313_00114.jpg

LM Start	9.75	Rating **	M	Issue No.	133
LM End	9.75	Issue Type +	En	Location *	LS
Category	Earthen Levee			GPS Latitude/Longitude	
				Start	End
Item	Vegetation			38.567888 °	38.567888 °
				-121.366734 °	-121.366734 °
DWR ID	DWR_NA0001_04_s _ 2012_133				
Comment Code					
V6 : Landscaping					
Inspector Comment					
Lemon tree, palm, and ivy planted within 10-ft of levee toe obstructs access and visibility.

View of landscaping at levee toe.

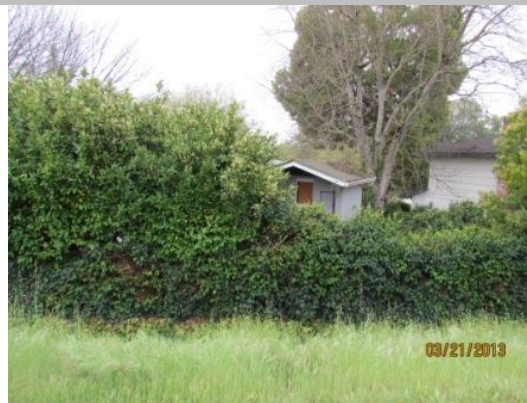
Photo 1 of 1 : SP_2017_NA0001_55_134_20170313_00115.jpg

LM Start	9.77	Rating **	U	Issue No.	134
LM End	9.77	Issue Type +	En	Location *	LS
Category	Earthen Levee			GPS Latitude/Longitude	
				Start	End
Item	Vegetation			38.567873 °	38.567873 °
				-121.366410 °	-121.366410 °
DWR ID	DWR_NA0001_04_s_2012_134				
Comment Code					
V6 : Landscaping					
Inspector Comment					
Ivy, hedge and play house is within 10-ft of levee toe.

View of landscaping and playhouse.

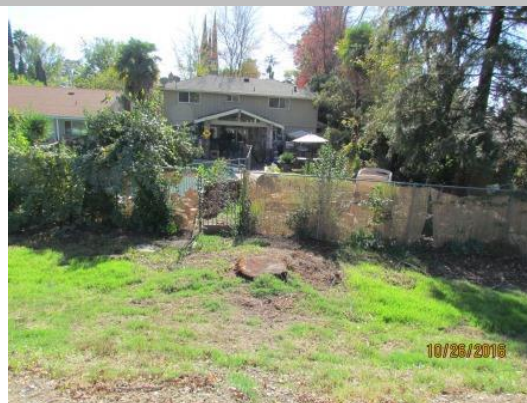
Photo 1 of 1 : SP_2017_NA0001_55_222_20170313_00174.jpg

LM Start	9.80	Rating **	N	Issue No.	222
LM End	9.81	Issue Type +	Ma	Location *	LS
Category	Earthen Levee			GPS Latitude/Longitude	
				Start	End
Item	Trim / Thin Trees			38.568107 °	38.568114 °
				-121.365842 °	-121.365747 °
DWR ID	DWR_NA0001_04_f_2016_222				
Comment Code					
T5 : Tree stumps.					
Inspector Comment					
2 tree stumps approximately 40 feet apart.

View of the tree stump at the landside levee toe.

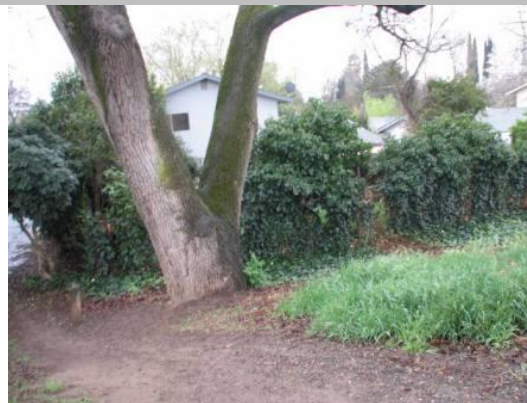
Photo 1 of 1 : SP_2017_NA0001_55_135_20170313_00116.jpg

LM Start	9.88	Rating **	U	Issue No.	135
LM End	9.88	Issue Type +	En	Location *	LS
Category	Earthen Levee			GPS Latitude/Longitude	
				Start	End
Item	Vegetation			38.568411 °	38.568411 °
				-121.364489 °	-121.364489 °
DWR ID	DWR_NA0001_04_s_2012_135				
Comment Code					
V6 : Landscaping					
Inspector Comment					
Tall hedge and ivy within 10-ft of landside levee toe.

03/16/2012 Landscaping is obstructing visibility.

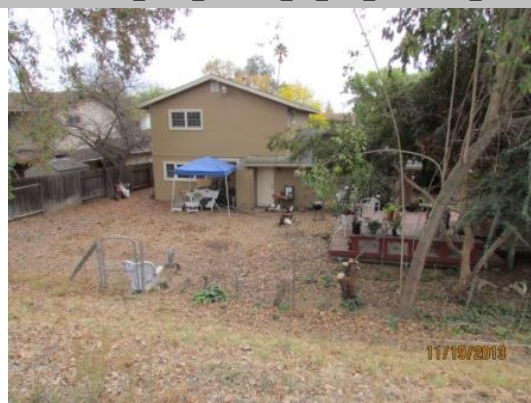
Photo 1 of 1 : SP_2017_NA0001_55_136_20170313_00117.jpg

LM Start	9.95	Rating **	M	Issue No.	136
LM End	9.95	Issue Type +	En	Location *	LS
Category	Earthen Levee			GPS Latitude/Longitude	
				Start	End
Item	Encroachments			38.568714 °	38.568714 °
				-121.363257 °	-121.363257 °
DWR ID	DWR_NA0001_04_s _ 2012_136				
Comment Code					
FE : Fence					
Inspector Comment					
Wire fence within 10-ft of landside levee toe.

View of the fence and tree stump at the landside levee toe.

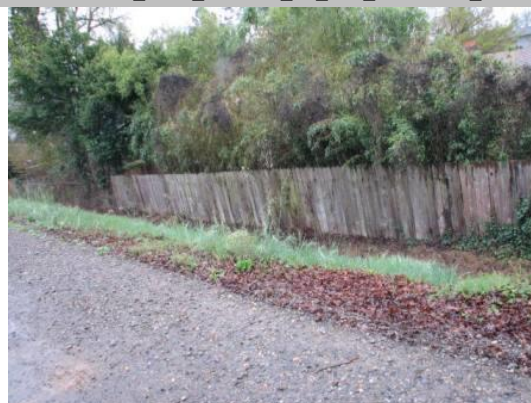
Photo 1 of 1 : SP_2017_NA0001_55_138_20170313_00118.jpg

LM Start	10.00	Rating **	U	Issue No.	138
LM End	10.00	Issue Type +	En	Location *	LS
Category	Earthen Levee			GPS Latitude/Longitude	
				Start	End
Item	Encroachments			38.568953 °	38.568953 °
				-121.362396 °	-121.362396 °
DWR ID	DWR_NA0001_04_s _ 2012_138				
Comment Code					
FE : Fence					
Inspector Comment					
03/16/2012 Wood privacy fence completely obstructs visibility and access.

03/16/2012 Wood privacy fence completely obstructs access and visibility.

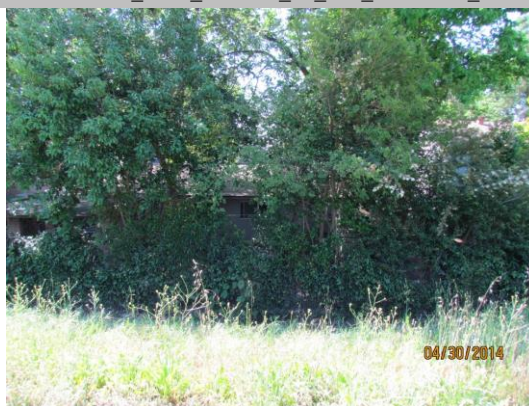
Photo 1 of 1 : SP_2017_NA0001_55_245_20170313_00188.jpg

LM Start	10.06	Rating **	U	Issue No.	245
LM End	10.06	Issue Type +	En	Location *	LS
Category	Earthen Levee			GPS Latitude/Longitude	
				Start	End
Item	Encroachments			38.569247 °	38.569247 °
				-121.361315 °	-121.361315 °
DWR ID	DWR_NA0001_04_s_2014_245				
Comment Code					
FE : Fence					
Inspector Comment					
Rod fence covered with vegetation within 10ft of levee toe.

View of the fence at the landside levee toe.

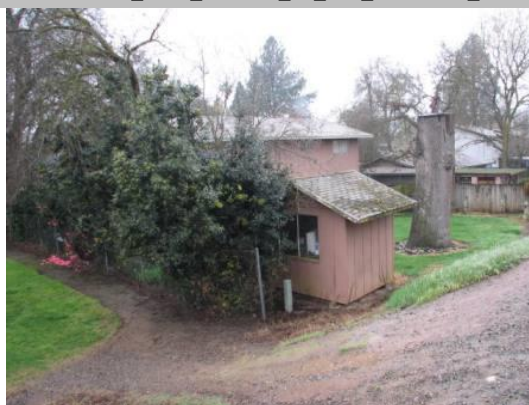
Photo 1 of 1 : SP_2017_NA0001_55_176_20170313_00151.jpg

LM Start	10.08	Rating **	U	Issue No.	176
LM End	10.08	Issue Type +	En	Location *	LS
Category	Earthen Levee			GPS Latitude/Longitude	
				Start	End
Item	Encroachments			38.569293 °	38.569293 °
				-121.361002 °	-121.361002 °
DWR ID	DWR_NA0001_04_s_2012_176				
Comment Code					
BU : Building					
Inspector Comment

03/16/2012 Wood structure within 15' of levee toe.

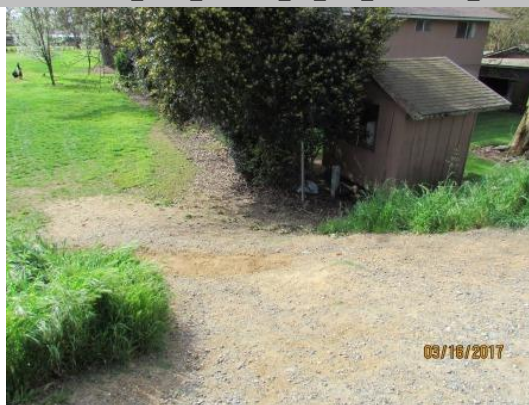
Photo 1 of 1 : SP_2017_NA0001_55_221_20170406_00253.jpg

LM Start	10.08	Rating **	M	Issue No.	221
LM End	10.08	Issue Type +	Ma	Location *	LS
Category	Earthen Levee			GPS Latitude/Longitude	
				Start	End
Item	Slope Stability			38.569290 °	38.569290 °
				-121.360960 °	-121.360960 °
DWR ID	DWR_NA0001_04_s_2017_221				
Comment Code					
S2 : Repair the levee slope damaged by foot traffic and prevent access where possible.					
Inspector Comment

View of the footpath on the levee slope.

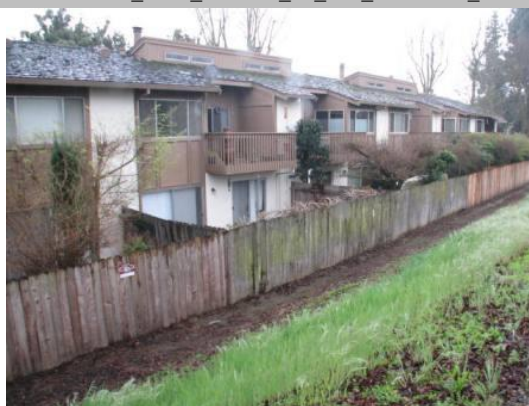
Photo 1 of 1 : SP_2017_NA0001_55_141_20170313_00120.jpg

LM Start	10.24	Rating **	U	Issue No.	141
LM End	10.27	Issue Type +	En	Location *	LS
Category	Earthen Levee			GPS Latitude/Longitude	
				Start	End
Item	Encroachments			38.569982 °	38.570118 °
				-121.358134 °	-121.357604 °
DWR ID	DWR_NA0001_04_s_2012_141				
Comment Code					
FE : Fence					
Inspector Comment					
Wooden fence behind six apartment units is within 10-ft of levee slope.

03/16/2012 Wood privacy fence completely obstructs access and visibility.

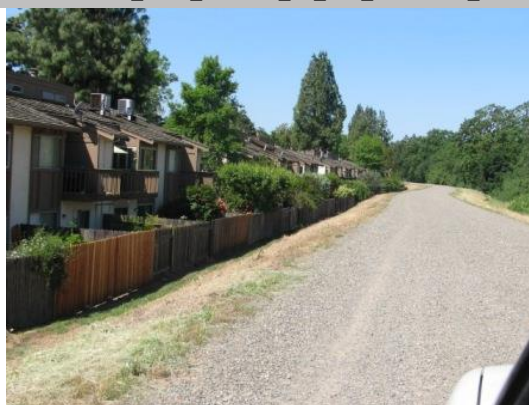
Photo 1 of 1 : SP_2017_NA0001_55_142_20170313_00121.jpg

LM Start	10.28	Rating **	U	Issue No.	142
LM End	10.30	Issue Type +	En	Location *	LS
Category	Earthen Levee			GPS Latitude/Longitude	
				Start	End
Item	Encroachments			38.570175 °	38.570229 °
				-121.357390 °	-121.357041 °
DWR ID	DWR_NA0001_04_s_2017_142				
Comment Code					
FE : Fence					
Inspector Comment					
Wooden fence behind six apartment units is within 10-ft of levee slope.

Wooden fence behind apartments within 10' of levee toe.

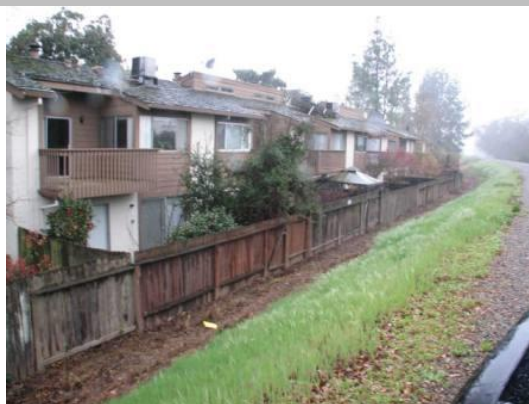
Photo 1 of 1 : SP_2017_NA0001_55_146_20170313_00125.jpg

LM Start	10.30	Rating **	U	Issue No.	146
LM End	10.32	Issue Type +	En	Location *	LS
Category	Earthen Levee			GPS Latitude/Longitude	
				Start	End
Item	Encroachments			38.570225 °	38.570245 °
				-121.357014 °	-121.356791 °
DWR ID	DWR_NA0001_04_s_2012_146				
Comment Code					
FE : Fence					
Inspector Comment					
Wooden fence behind 6 apartments.

03/16/2012 Wood privacy fence completely obstructs access and visibility.

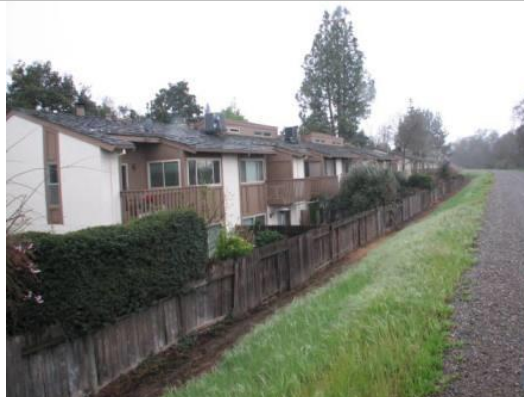
Photo 1 of 1 : SP_2017_NA0001_55_143_20170313_00122.jpg

LM Start	10.32	Rating **	U	Issue No.	143
LM End	10.34	Issue Type +	En	Location *	LS
Category	Earthen Levee			GPS Latitude/Longitude	
				Start	End
Item	Encroachments			38.570257 °	38.570297 °
				-121.356783 °	-121.356403 °
DWR ID	DWR_NA0001_04_s _ 2012_143				
Comment Code					
FE : Fence					
Inspector Comment					
Wooden fence behind six apartment units is within 10-ft of levee slope.

03/16/2012 Wood privacy fence completely obstructs access and visibility.

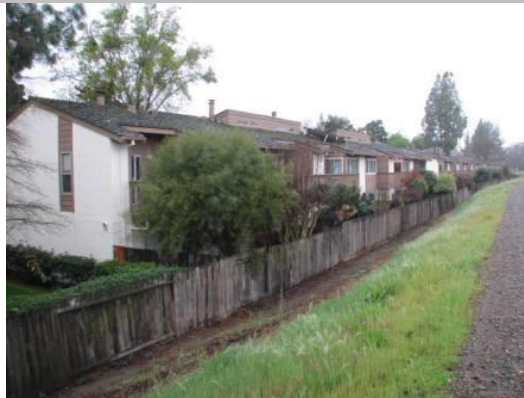
Photo 1 of 1 : SP_2017_NA0001_55_144_20170313_00123.jpg

LM Start	10.35	Rating **	U	Issue No.	144
LM End	10.37	Issue Type +	En	Location *	LS
Category	Earthen Levee			GPS Latitude/Longitude	
				Start	End
Item	Encroachments			38.570325 °	38.570397 °
				-121.356185 °	-121.355757 °
DWR ID	DWR_NA0001_04_s _ 2012_144				
Comment Code					
FE : Fence					
Inspector Comment					
Wooden fence behind six apartment units is within 10-ft of levee slope.

03/16/2012 Wood privacy fence completely obstructs access and visibility.

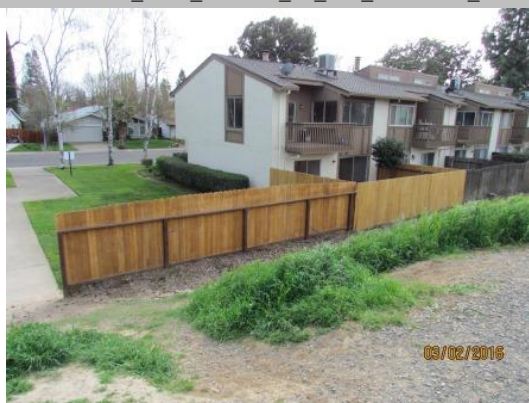
Photo 1 of 1 : SP_2017_NA0001_55_145_20170313_00124.jpg

LM Start	10.38	Rating **	U	Issue No.	145
LM End	10.41	Issue Type +	En	Location *	LS
Category	Earthen Levee			GPS Latitude/Longitude	
				Start	End
Item	Encroachments			38.570417 °	38.570500 °
				-121.355625 °	-121.355151 °
DWR ID	DWR_NA0001_04_s_2012_145				
Comment Code					
FE : Fence					
Inspector Comment					
Wooden fence behind six apartment units is within 10-ft of levee slope.

Wood privacy fence completely obstructs access and visibility.

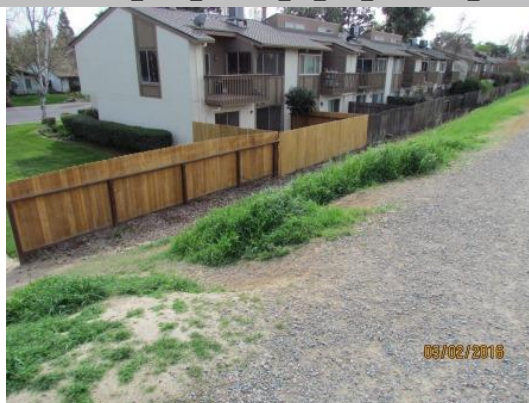
Photo 1 of 1 : SP_2017_NA0001_55_228_20170313_00178.jpg

LM Start	10.42	Rating **	A/W	Issue No.	228
LM End	10.42	Issue Type +	Ma	Location *	LS
Category	Earthen Levee			GPS Latitude/Longitude	
				Start	End
Item	Slope Stability			38.570536 °	38.570536 °
				-121.354957 °	-121.354957 °
DWR ID	DWR_NA0001_04_s_2016_228				
Comment Code					
S2 : Repair the levee slope damaged by foot traffic and prevent access where possible.					
Inspector Comment					
The erosion of the levee slope from the footpath appears to be stable at this time and should be monitored.

View of the fence at the landside levee toe.

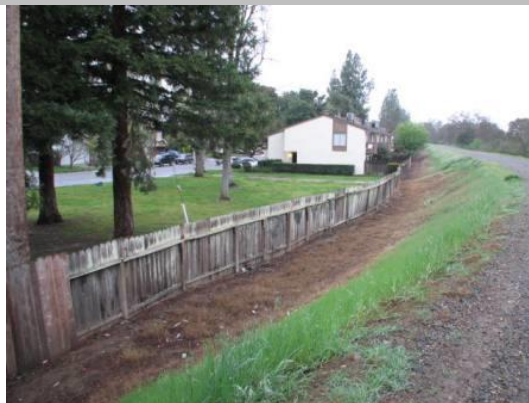
Photo 1 of 1 : SP_2017_NA0001_55_147_20170313_00126.jpg

LM Start	10.43	Rating **	U	Issue No.	147
LM End	10.43	Issue Type +	En	Location *	LS
Category	Earthen Levee			GPS Latitude/Longitude	
				Start	End
Item	Encroachments			38.570542 °	38.570542 °
				-121.354772 °	-121.354772 °
DWR ID	DWR_NA0001_04_s _ 2012_147				
Comment Code					
FE : Fence					
Inspector Comment					
Wooden privacy fence.

03/16/2012 Wood privacy fence completely obstructs access and visibility.

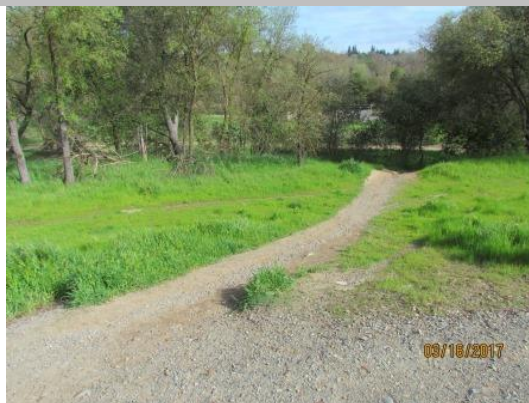
Photo 1 of 1 : SP_2017_NA0001_55_219_20170406_00252.jpg

LM Start	10.44	Rating **	A/W	Issue No.	219
LM End	10.44	Issue Type +	Ma	Location *	WS
Category	Earthen Levee			GPS Latitude/Longitude	
				Start	End
Item	Slope Stability			38.570559 °	38.570559 °
				-121.354514 °	-121.354514 °
DWR ID	DWR_NA0001_04_s _ 2017_219				
Comment Code					
S2 : Repair the levee slope damaged by foot traffic and prevent access where possible.					
Inspector Comment					
The erosion of the levee slope from the footpath appears to be stable at this time and should be monitored.

View of the footpath on the levee slope.

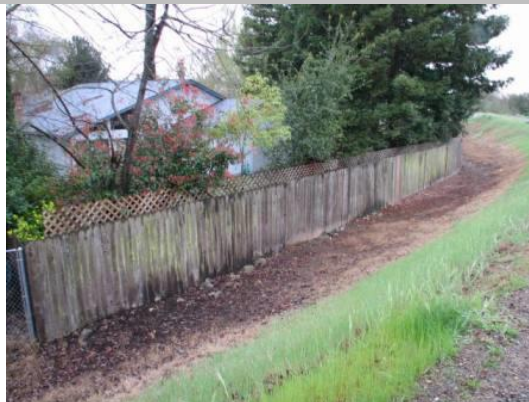
Photo 1 of 1 : SP_2017_NA0001_55_148_20170313_00127.jpg

LM Start	10.45	Rating **	U	Issue No.	148
LM End	10.45	Issue Type +	En	Location *	LS
Category	Earthen Levee			GPS Latitude/Longitude	
				Start	End
Item	Encroachments			38.570524 °	38.570524 °
				-121.354359 °	-121.354359 °
DWR ID	DWR_NA0001_04_s _ 2012_148				
Comment Code					
FE : Fence					
Inspector Comment					
Wooden privacy fence obstructs visibility and access.

03/16/2012 Wood privacy fence completely obstructs access and visibility.

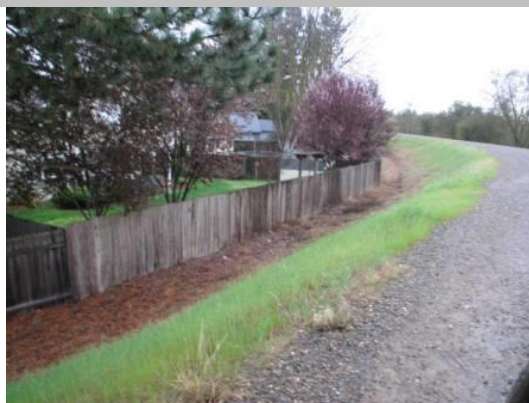
Photo 1 of 1 : SP_2017_NA0001_55_149_20170313_00128.jpg

LM Start	10.48	Rating **	U	Issue No.	149
LM End	10.48	Issue Type +	En	Location *	LS
Category	Earthen Levee			GPS Latitude/Longitude	
				Start	End
Item	Encroachments			38.570234 °	38.570234 °
				-121.353862 °	-121.353862 °
DWR ID	DWR_NA0001_04_s_2012_149				
Comment Code					
FE : Fence					
Inspector Comment					
Wooden privacy fence is within 10-ft of levee toe.

03/16/2012 Wood privacy fence completely obstructs access and visibility.

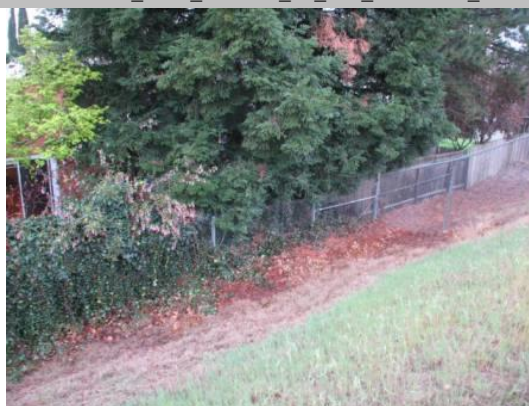
Photo 1 of 1 : SP_2017_NA0001_55_150_20170313_00129.jpg

LM Start	10.49	Rating **	U	Issue No.	150
LM End	10.49	Issue Type +	En	Location *	LS
Category	Earthen Levee			GPS Latitude/Longitude	
				Start	End
Item	Encroachments			38.570095 °	38.570095 °
				-121.353807 °	-121.353807 °
DWR ID	DWR_NA0001_04_s _ 2012_150				
Comment Code					
FE : Fence					
Inspector Comment					
Wooden privacy fence within 10-ft of levee toe.

03/16/2012 Wood privacy fence completely obstructs access and visibility.

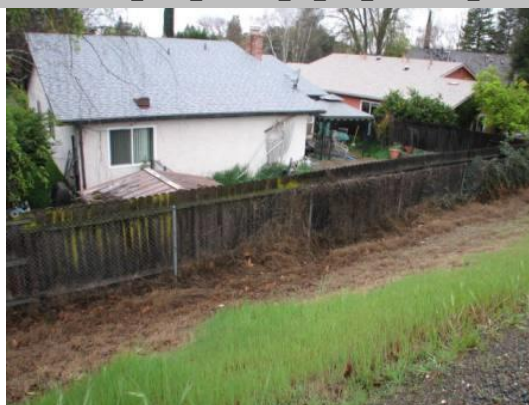
Photo 1 of 1 : SP_2017_NA0001_55_151_20170313_00130.jpg

LM Start	10.51	Rating **	U	Issue No.	151
LM End	10.51	Issue Type +	En	Location *	LS
Category	Earthen Levee			GPS Latitude/Longitude	
				Start	End
Item	Encroachments			38.569921 °	38.569921 °
				-121.353643 °	-121.353643 °
DWR ID	DWR_NA0001_04_s _ 2012_151				
Comment Code					
FE : Fence					
Inspector Comment					
Wooden privacy fence within 10-ft of levee toe.

03/16/2012 Wood privacy fence completely obstructs access and visibility.

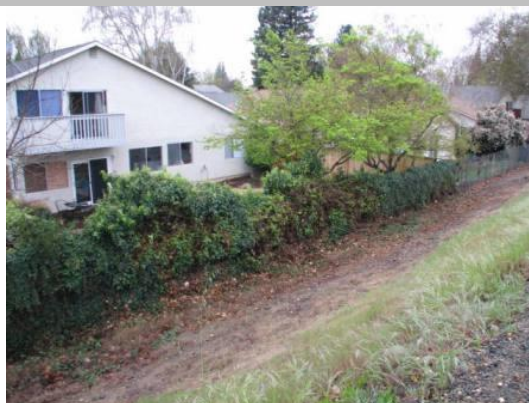
Photo 1 of 1 : SP_2017_NA0001_55_153_20170313_00132.jpg

LM Start	10.57	Rating **	U	Issue No.	153
LM End	10.57	Issue Type +	En	Location *	LS
Category	Earthen Levee			GPS Latitude/Longitude	
				Start	End
Item	Encroachments			38.569166 °	38.569166 °
				-121.353272 °	-121.353272 °
DWR ID	DWR_NA0001_04_s_2012_153				
Comment Code					
FE : Fence					
Inspector Comment					
Wooden privacy fence and ivy within 10-ft of levee toe.

03/16/2012 Wood privacy fence completely obstructs access and visibility.

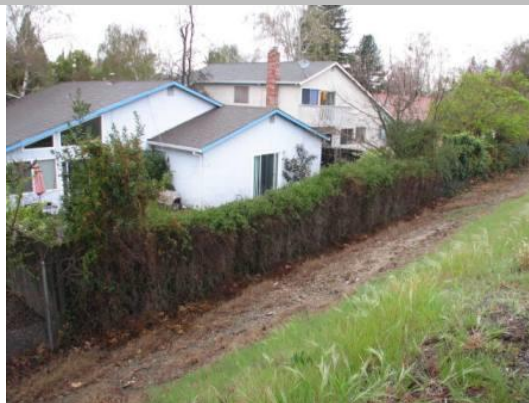
Photo 1 of 1 : SP_2017_NA0001_55_154_20170313_00133.jpg

LM Start	10.58	Rating **	U	Issue No.	154
LM End	10.58	Issue Type +	En	Location *	LS
Category	Earthen Levee			GPS Latitude/Longitude	
				Start	End
Item	Encroachments			38.569013 °	38.569013 °
				-121.353218 °	-121.353218 °
DWR ID	DWR_NA0001_04_s_2012_154				
Comment Code					
FE : Fence					
Inspector Comment					
Wooden privacy fence within 10-ft of levee toe.

03/16/2012 Wood privacy fence completely obstructs access and visibility.

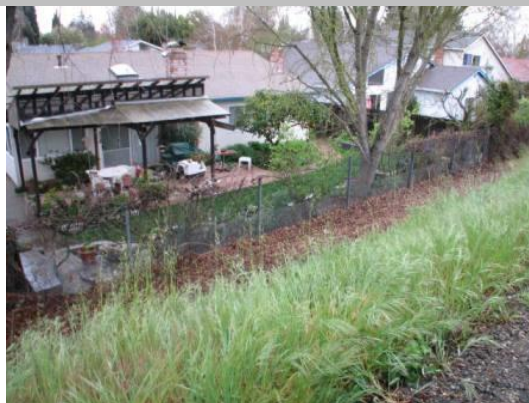
Photo 1 of 1 : SP_2017_NA0001_55_155_20170313_00134.jpg

LM Start	10.59	Rating **	M	Issue No.	155
LM End	10.59	Issue Type +	En	Location *	LS
Category	Earthen Levee			GPS Latitude/Longitude	
				Start	End
Item	Vegetation			38.568892 °	38.568892 °
				-121.353162 °	-121.353162 °
DWR ID	DWR_NA0001_04_s_2012_155				
Comment Code					
V6 : Landscaping					
Inspector Comment					
Trees and bushes are within 10-ft of the levee toe.

03/16/2012 Trees and bushes within 10' of levee toe.

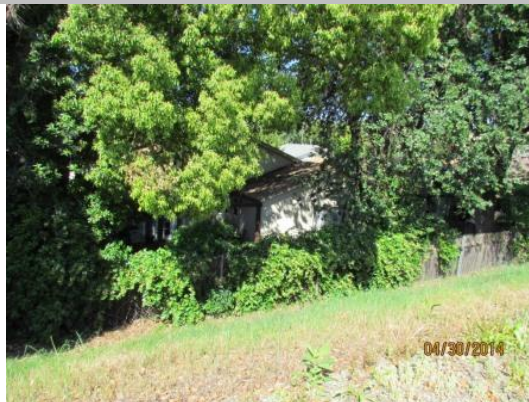
Photo 1 of 1 : SP_2017_NA0001_55_156_20170313_00135.jpg

LM Start	10.60	Rating **	U	Issue No.	156
LM End	10.60	Issue Type +	En	Location *	LS
Category	Earthen Levee			GPS Latitude/Longitude	
				Start	End
Item	Encroachments			38.568713 °	38.568713 °
				-121.353150 °	-121.353150 °
DWR ID	DWR_NA0001_04_s_2012_156				
Comment Code					
FE : Fence					
Inspector Comment					
Chain link fence and landscaping within 10-ft of levee toe.

View of the fence at the landside levee toe obstructing visibility and access.

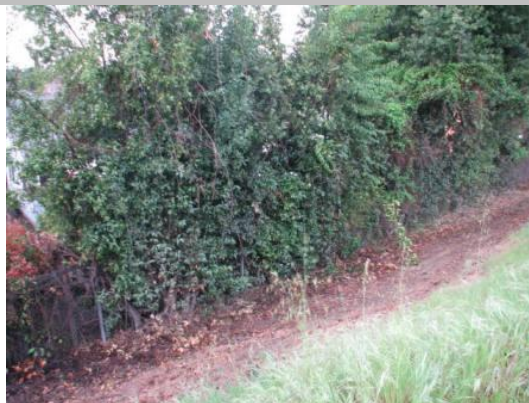
Photo 1 of 1 : SP_2017_NA0001_55_157_20170313_00136.jpg

LM Start	10.61	Rating **	M	Issue No.	157
LM End	10.61	Issue Type +	En	Location *	LS
Category	Earthen Levee			GPS Latitude/Longitude	
				Start	End
Item	Vegetation			38.568608 °	38.568608 °
				-121.353054 °	-121.353054 °
DWR ID	DWR_NA0001_04_s _ 2012_157				
Comment Code					
V6 : Landscaping					
Inspector Comment					
Tall hedge and vine on levee toe.

03/16/2012 Landscaping obstructs visibility

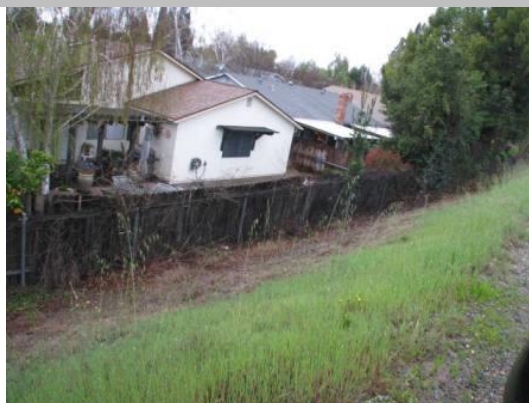
Photo 1 of 1 : SP_2017_NA0001_55_158_20170313_00137.jpg

LM Start	10.62	Rating **	U	Issue No.	158
LM End	10.62	Issue Type +	En	Location *	LS
Category	Earthen Levee			GPS Latitude/Longitude	
				Start	End
Item	Encroachments			38.568355 °	38.568355 °
				-121.353033 °	-121.353033 °
DWR ID	DWR_NA0001_04_s _ 2012_158				
Comment Code					
FE : Fence					
Inspector Comment					
Wooden privacy fence within 10-ft of levee toe.

03/16/2012 Wood privacy fence completely obstructs access and visibility.

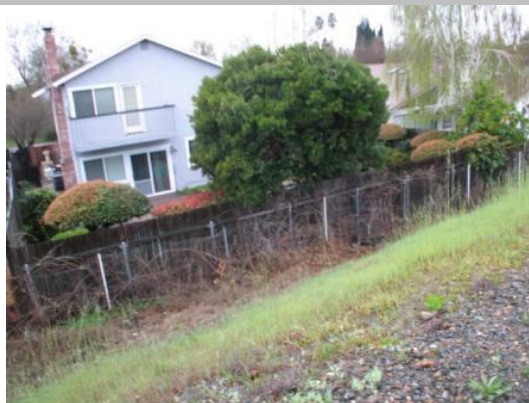
Photo 1 of 1 : SP_2017_NA0001_55_159_20170313_00138.jpg

LM Start	10.63	Rating **	U	Issue No.	159
LM End	10.63	Issue Type +	En	Location *	LS
Category	Earthen Levee			GPS Latitude/Longitude	
				Start	End
Item	Encroachments			38.568313 °	38.568313 °
				-121.352941 °	-121.352941 °
DWR ID	DWR_NA0001_04_s_2012_159				
Comment Code					
FE : Fence					
Inspector Comment					
Wooden privacy fence within 10-ft of levee toe.

03/16/2012 Wood privacy fence completely obstructs access and visibility.

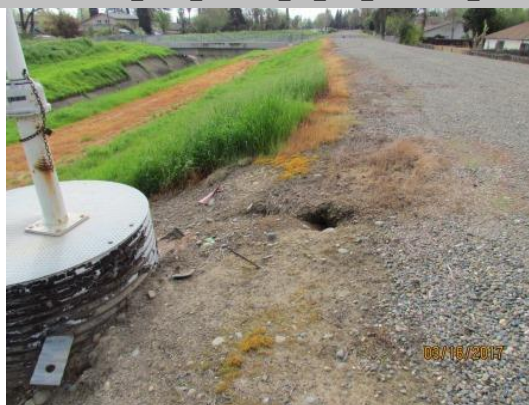
Photo 1 of 1 : SP_2017_NA0001_55_227_20170406_00251.jpg

LM Start	10.63	Rating **	M	Issue No.	227
LM End	10.63	Issue Type +	Ma	Location *	WS
Category	Earthen Levee			GPS Latitude/Longitude	
				Start	End
Item	Animal Control			38.568301 °	38.568301 °
				-121.352937 °	-121.352937 °
DWR ID	DWR_NA0001_04_s_2016_227				
Comment Code					
A1 : Exterminate rodents and backfill and compact or grout burrows.					
Inspector Comment

View of the rodent burrow on the levee slope, looking upstream.

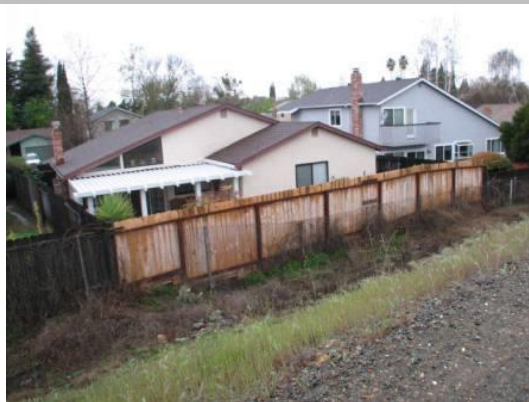
Photo 1 of 1 : SP_2017_NA0001_55_160_20170313_00139.jpg

LM Start	10.64	Rating **	U	Issue No.	160
LM End	10.64	Issue Type +	En	Location *	LS
Category	Earthen Levee			GPS Latitude/Longitude	
				Start	End
Item	Encroachments			38.568188 °	38.568188 °
				-121.352864 °	-121.352864 °
DWR ID	DWR_NA0001_04_f_2012_160				
Comment Code					
FE : Fence					
Inspector Comment					
Tall wooden privacy fence within 10-ft of levee toe.

03/16/2012 Wood privacy fence completely obstructs access and visibility.

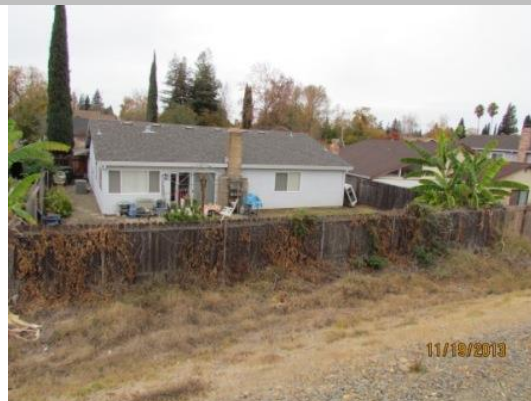
Photo 1 of 1 : SP_2017_NA0001_55_161_20170313_00140.jpg

LM Start	10.65	Rating **	U	Issue No.	161
LM End	10.65	Issue Type +	En	Location *	LS
Category	Earthen Levee			GPS Latitude/Longitude	
				Start	End
Item	Encroachments			38.568058 °	38.568058 °
				-121.352785 °	-121.352785 °
DWR ID	DWR_NA0001_04_s_2012_161				
Comment Code					
FE : Fence					
Inspector Comment					
Wooden privacy fence and vine within 10-ft of levee toe.

View of wood privacy fence completely obstructing access and visibility.

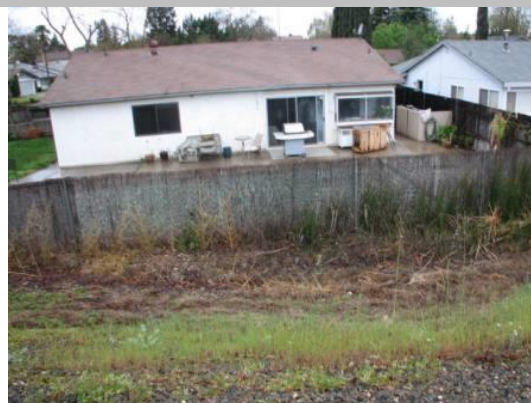
Photo 1 of 1 : SP_2017_NA0001_55_179_20170313_00154.jpg

LM Start	10.66	Rating **	U	Issue No.	179
LM End	10.66	Issue Type +	En	Location *	LS
Category	Earthen Levee			GPS Latitude/Longitude	
				Start	End
Item	Encroachments			38.567917 °	38.567917 °
				-121.352698 °	-121.352698 °
DWR ID	DWR_NA0001_04_s_2012_179				
Comment Code					
FE : Fence					
Inspector Comment					
Chainlink fence with bamboo mats prevent visibility.

03/16/2012 Bamboo panels on chainlink fence completely obstruct visibility.

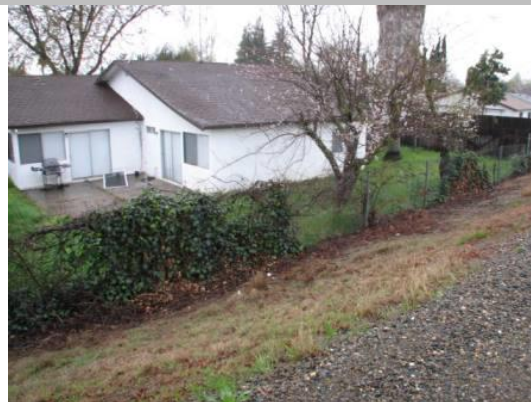
Photo 1 of 1 : SP_2017_NA0001_55_178_20170313_00153.jpg

LM Start	10.68	Rating **	M	Issue No.	178
LM End	10.68	Issue Type +	En	Location *	LS
Category	Earthen Levee			GPS Latitude/Longitude	
				Start	End
Item	Encroachments			38.567552 °	38.567552 °
				-121.352500 °	-121.352500 °
DWR ID	DWR_NA0001_04_s_2012_178				
Comment Code					
FE : Fence					
Inspector Comment					
Chainlink fence

03/16/2012 Chainlink fence partially blocks visibility.

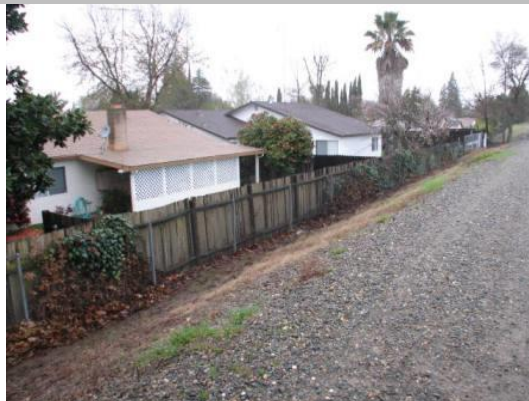
Photo 1 of 1 : SP_2017_NA0001_55_162_20170313_00141.jpg

LM Start	10.70	Rating **	U	Issue No.	162
LM End	10.70	Issue Type +	En	Location *	LS
Category	Earthen Levee			GPS Latitude/Longitude	
				Start	End
Item	Encroachments			38.567402 °	38.567402 °
				-121.352415 °	-121.352415 °
DWR ID	DWR_NA0001_04_s_2012_162				
Comment Code					
FE : Fence					
Inspector Comment					
Wooden privacy fence within 10-ft of levee toe.

03/16/2012 Wood privacy fence completely obstructs access and visibility.

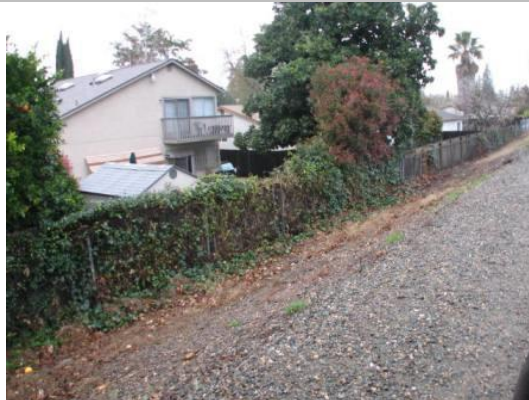
Photo 1 of 1 : SP_2017_NA0001_55_163_20170313_00142.jpg

LM Start	10.71	Rating **	U	Issue No.	163
LM End	10.71	Issue Type +	En	Location *	LS
Category	Earthen Levee			GPS Latitude/Longitude	
				Start	End
Item	Encroachments			38.567250 °	38.567250 °
				-121.352341 °	-121.352341 °
DWR ID	DWR_NA0001_04_s_2012_163				
Comment Code					
FE : Fence					
Inspector Comment					
Wooden privacy fence and landscaping within 10-ft of levee toe.

03/16/2012 Wood privacy fence completely obstructs access and visibility.

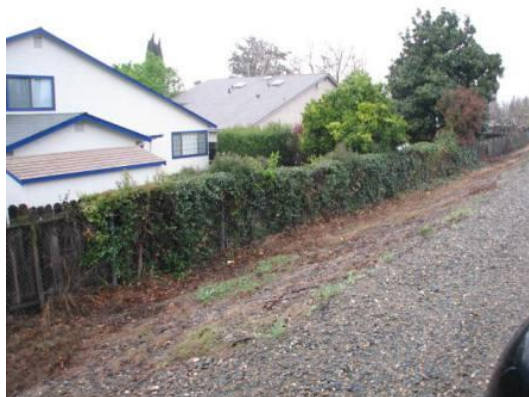
Photo 1 of 1 : SP_2017_NA0001_55_172_20170313_00150.jpg

LM Start	10.72	Rating **	U	Issue No.	172
LM End	10.72	Issue Type +	En	Location *	LS
Category	Earthen Levee			GPS Latitude/Longitude	
				Start	End
Item	Encroachments			38.567008 °	38.567008 °
				-121.352226 °	-121.352226 °
DWR ID	DWR_NA0001_04_s_2012_172				
Comment Code					
FE : Fence					
Inspector Comment					
Wooden privacy fence.

03/16/2012 Wood privacy fence completely obstructs access and visibility.
